Contactless Measurement of Integrity of Silicone Coating on Self-Expandable Esophageal Nitinol Stents

Martin Kopeček^{1,*}, Jiří Záhora¹, Aleš Bezrouk¹

Acta Medica (Hradec Králové) 2022; 65(1): 18–24

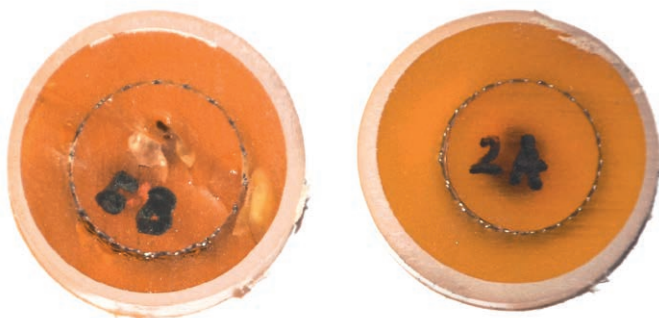
Fig. 2 Layer integrity of the nitinol wire, silicone coating and resin after waterjet cutting.

of this technology, the material is unaffected by any thermal effects, in contrast to other applicable cutting methods (laser, plasma, oxyfuel cutting). The cutting gap thickness when using a hydroabrasive beam is between 0.8 mm and 2.5 mm. The sample cutting procedure involves minimum jet force acting on the material, no microcracks are formed and a high-quality cut, free from burrs, is obtained. This helped create smooth cuts where the nitinol wires (16), silicone and support resin were not mostly destroyed, as shown in Figure 2.
